PIC24FJ64GA004 Family Silicon Errata and Data Sheet Clarification

The PIC24FJ64GA004 family devices that you have received conform functionally to the current Device Data Sheet (DS39881D), except for the anomalies described in this document.

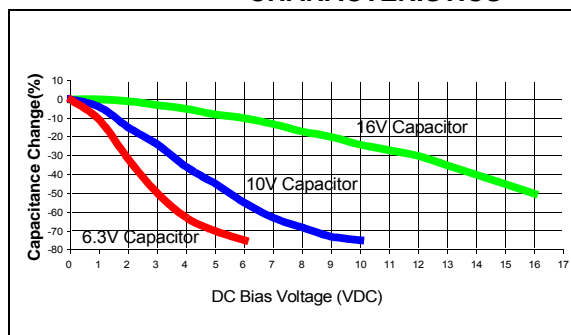
FIGURE 2-4 DC BIAS VOLTAGE vs. CAPACITANCE CHARACTERISTICS

A typical DC bias voltage vs. capacitance graph for 16V, 10V and 6.3V rated capacitors is shown in Figure 2-4.

When selecting a ceramic capacitor to be used with the internal voltage regulator, it is suggested to select a high-voltage rating, so that the operating voltage is a small percentage of the maximum rated capacitor voltage. For example, choose a ceramic capacitor rated at 16V for the 2.5V core voltage. Suggested capacitors are shown in Table 2-1.
